# Curly-leaf pondweed (*Potamogeton crispus*) in Green Lake, Isanti County, Minnesota

DOW 30013600, 832.88 acres, 357 littoral acres

## 2024 CLP Treatment Program Information

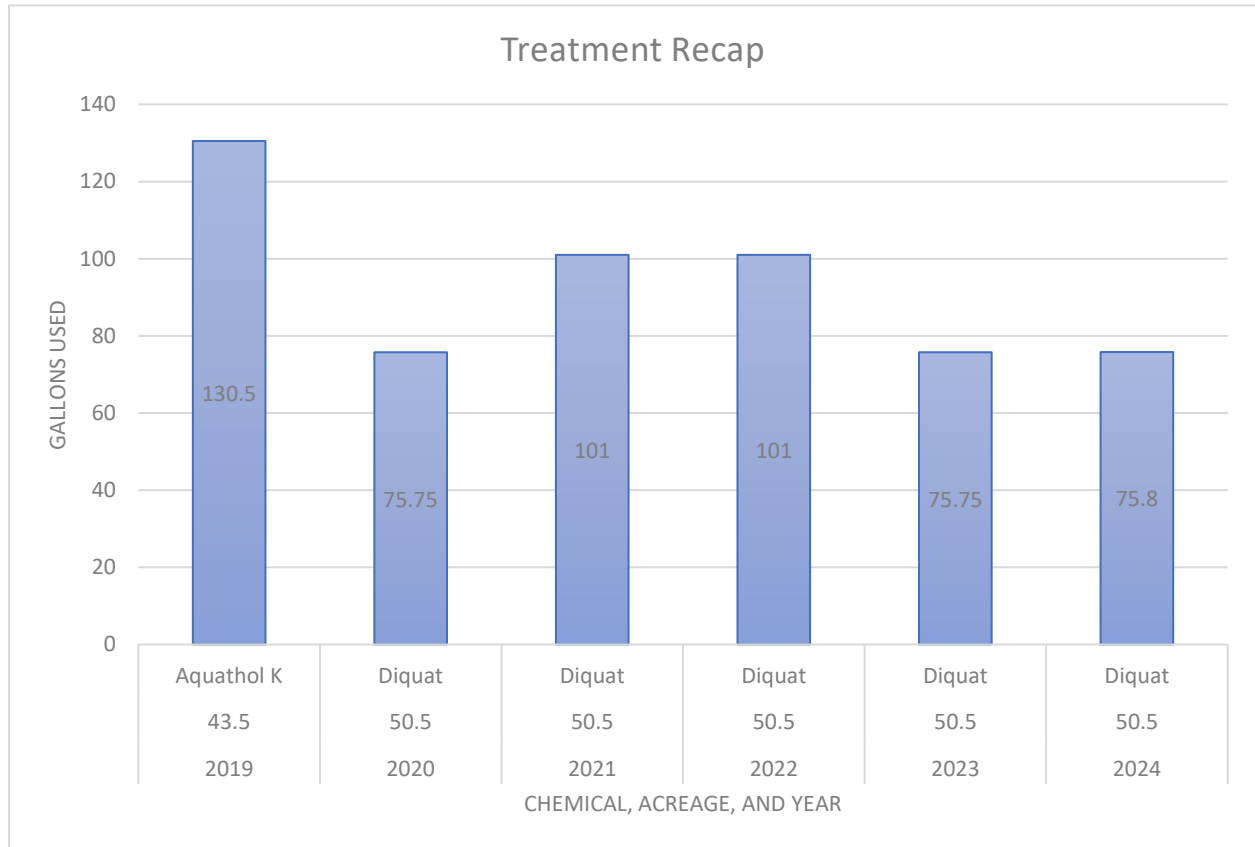
**Graph 1.)** Treatment recap showing the past years acreage, chemical, and gallons used.

Over the past 6 years the treatment sites and acreage have remained relatively the same. This is indicative of a massive seedbed in the sediment of these historic sites. The challenge with this plant is its ability to grow under the ice in winter and by spring drop its turions (“seeds”) and die back rapidly, making the window of time for treatment limited to early spring so it can be removed before its production of turions. These turions can live in the sediment for 5-7+ years and still be viable, making that early treatment key for successful control. The 2024 season was highly concerned with this plant’s abilities due to the weak winter and more sunlight being able to go through the thin ice with no snow cover, allowing more photosynthesis, causing the plants to grow and reproduce faster. To gain control of Green Lake, Lake restoration plans to treat these historic sites annually, suppressing the addition of new turions in the seedbed, which will control the spread of CLP throughout the lake. Ultimately, Green Lake was able to handle these challenges presented and is headed in the correct direction with CLP management yielding better use of the lake in each treatment year and working at the long-term goal of reducing the presence of CLP in Green Lake.
