Eurasian Watermilfoil (EWM) Delineation Report

Green Lake (Isanti County)

Survey Date: 7/21/2020

Survey & Report Completed by: Eric Fieldseth, AIS Consulting Services

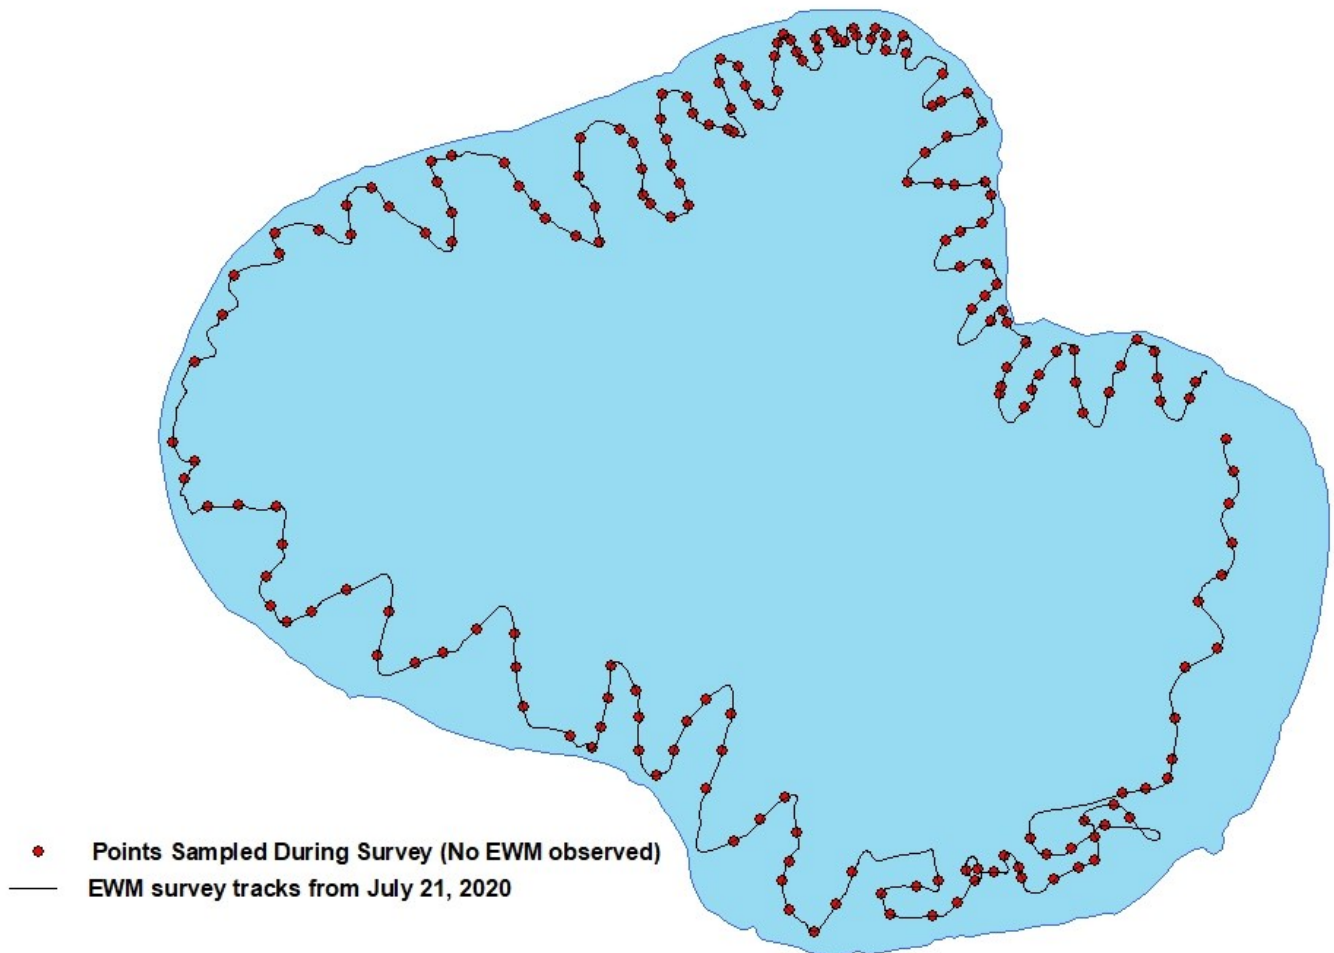
Figure 1. Results from Green Lake EWM Delineation on July 21, 2020

During our survey, we sampled 192 locations around the lake. We did not observe any Eurasian Watermilfoil during the survey. Native species observed included Coontail, Clasp Leaf Pondweed, Chara and Bushy Pondweed (*Najas flexilis*). We also observed some scattered Curlyleaf Pondweed plants, but overall they were sparse. Coontail appeared to be the most abundant plant growing during this survey. Dense growth of Coontail was found along the shoreline in many areas of the lake. Filamentous algae was often found growing on the Coontail, creating the appearance of the thick mats of vegetation around the lake. The Coontail with filamentous algae growth were at nuisance levels in some areas of the lake, and are likely impacting navigation in those areas. Pictures of Coontail growth with filamentous algae can be found on the final page of this report.

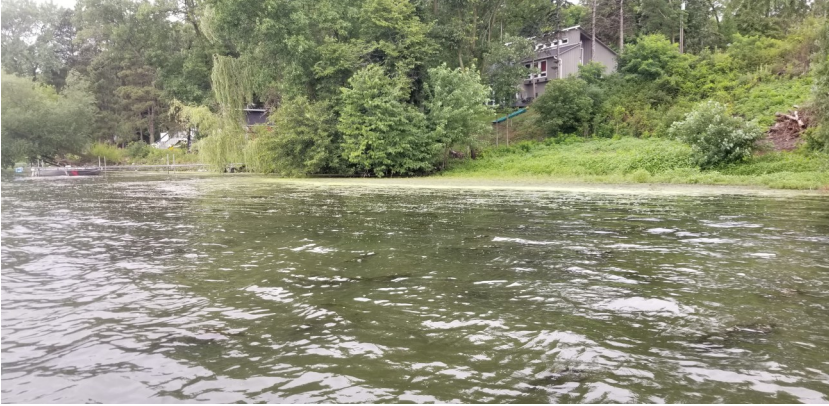
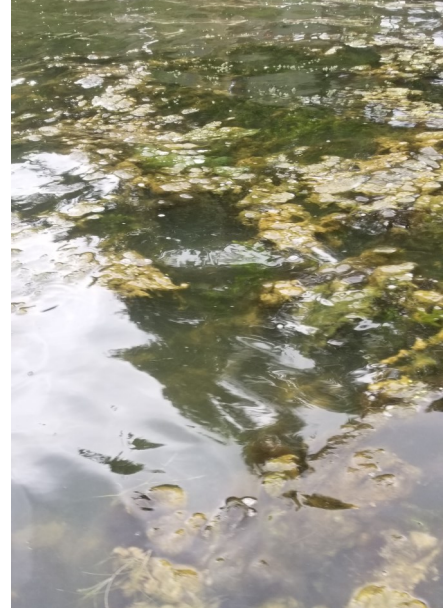
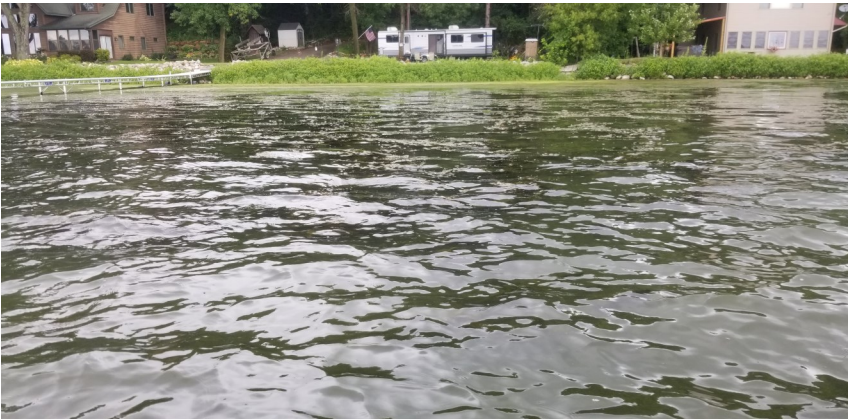
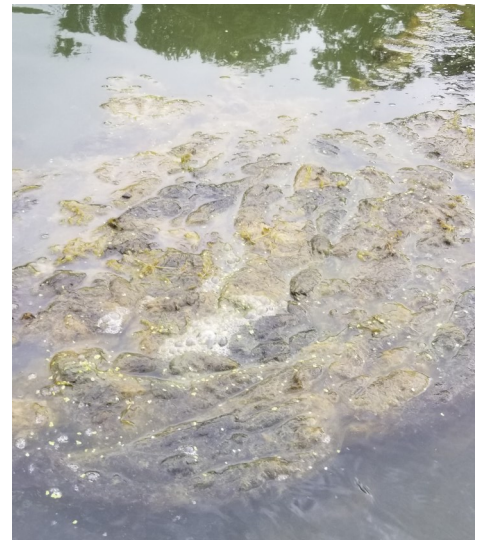
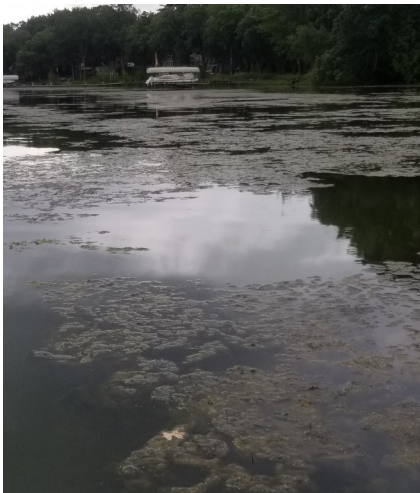
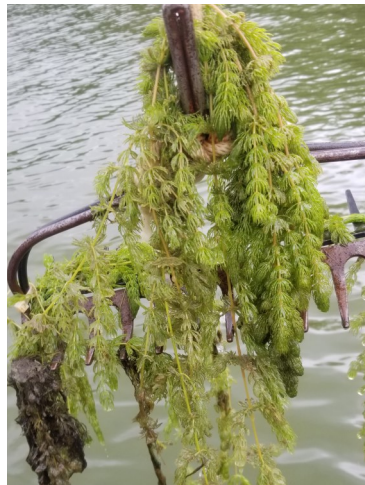
Images from July 21, 2020 EWM survey. Dense Coontail growth with filamentous algae attached.
